PREVIOUS FLIGHT ANOMALIES BACKUP

STS-109 IN-FLIGHT ANOMALIES

STS-104 IN-FLIGHT ANOMALIES

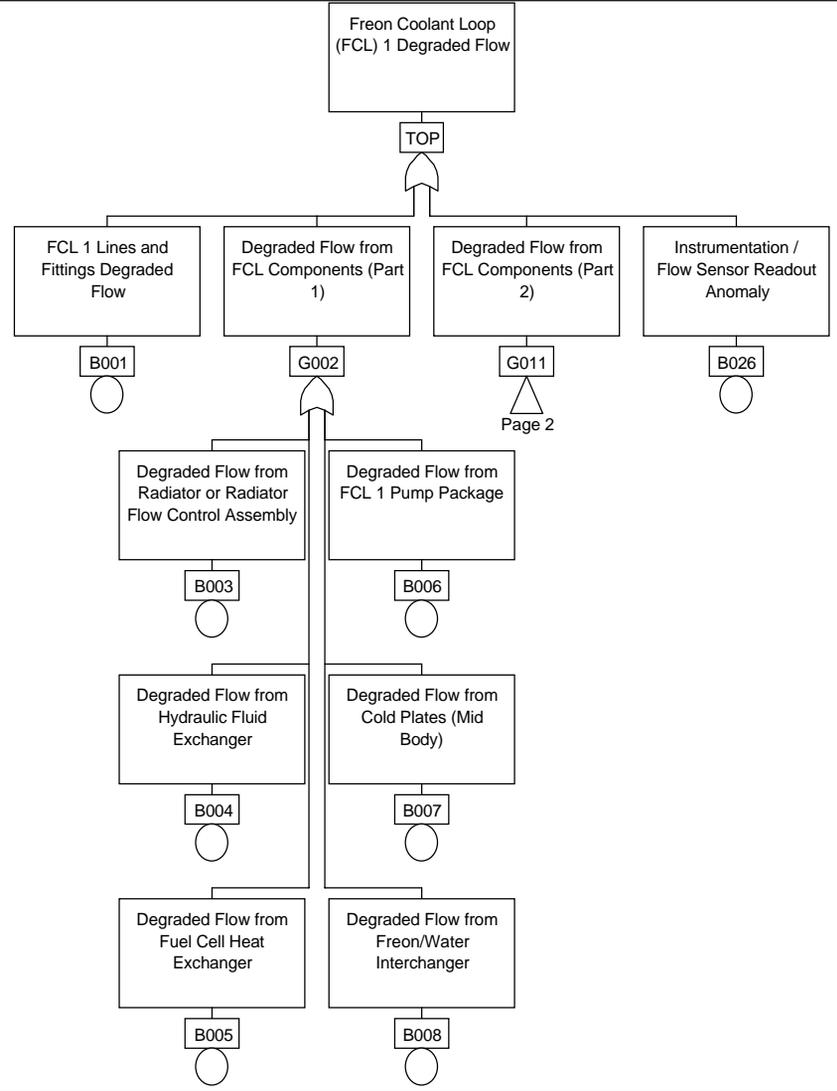
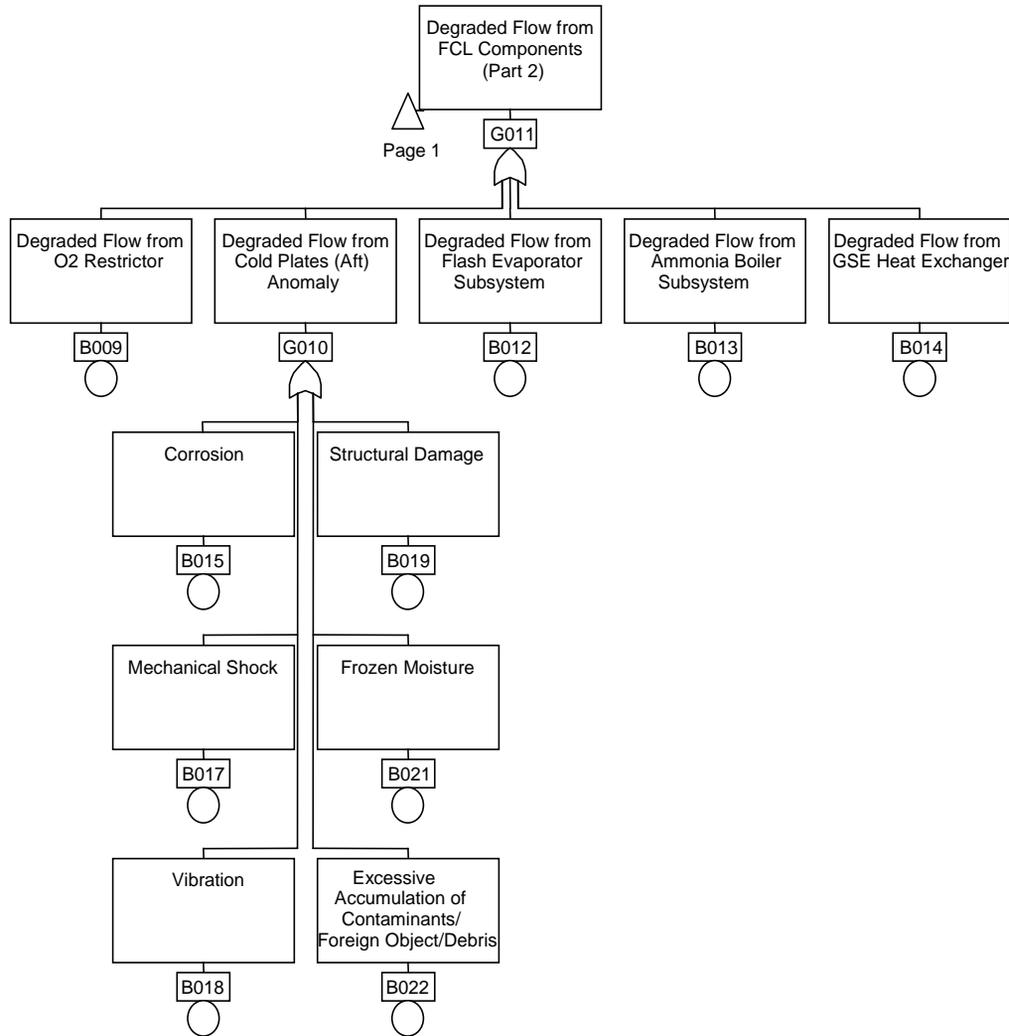
STS-109-V-01: FREON COOLANT LOOP 1 DEGRADED AFT COLD PLATE FLOW

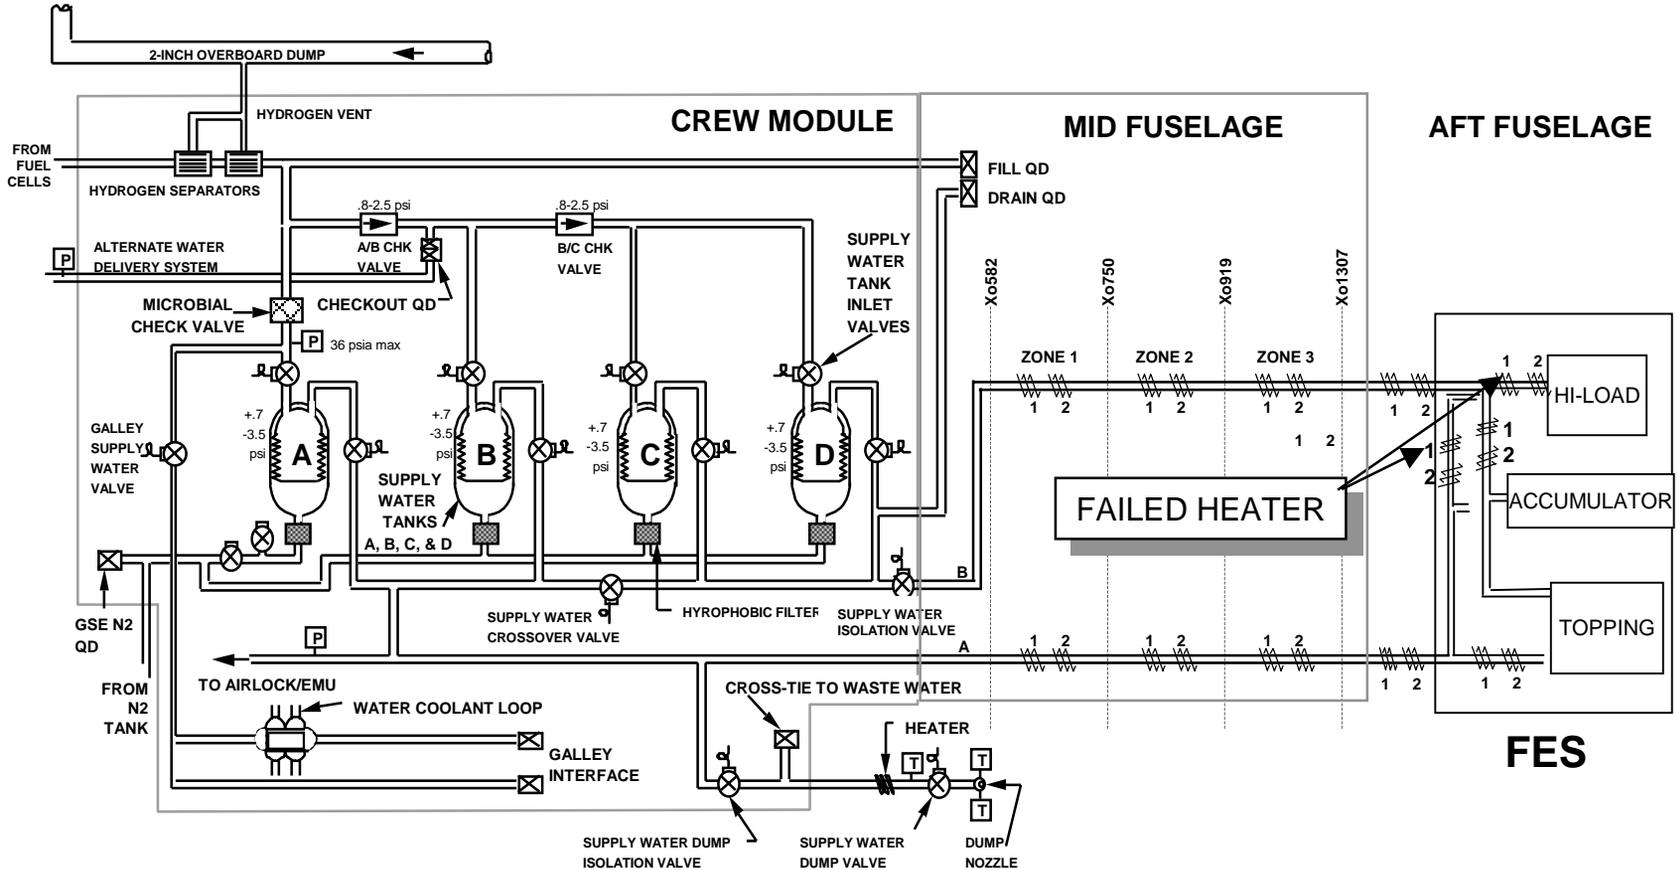
SUPPLY WATER SYSTEM

- FES hi-load and accumulator H₂O feed line A, heater 1 failed off

- Two redundant heater strings provide water line temperature control to prevent freezing
 - Hi-load line temperatures cycle between 150°F and 180°F
 - Accumulator line temperatures typically cycle between 75°F and 95°F
- The heater performed nominally until approximately MET 003:13:00
 - Line temperatures dropped to 90°F and 53°F respectively
 - Data showed heater cycling before failing indicating possible thermostat failure
- Crew switched to redundant heater string which performed nominally for the rest of the mission

- Post-flight troubleshooting did not duplicate the anomaly
- Most probable cause is a sticky thermostat
- The thermostat was removed and replaced
- The system was successfully retested

- In the event of a heater failure, the redundant heater string may be used
- Procedures to prevent freezing and recover the line for entry are available if both heaters fail
- FES heater string operation was verified as part of ground checkout

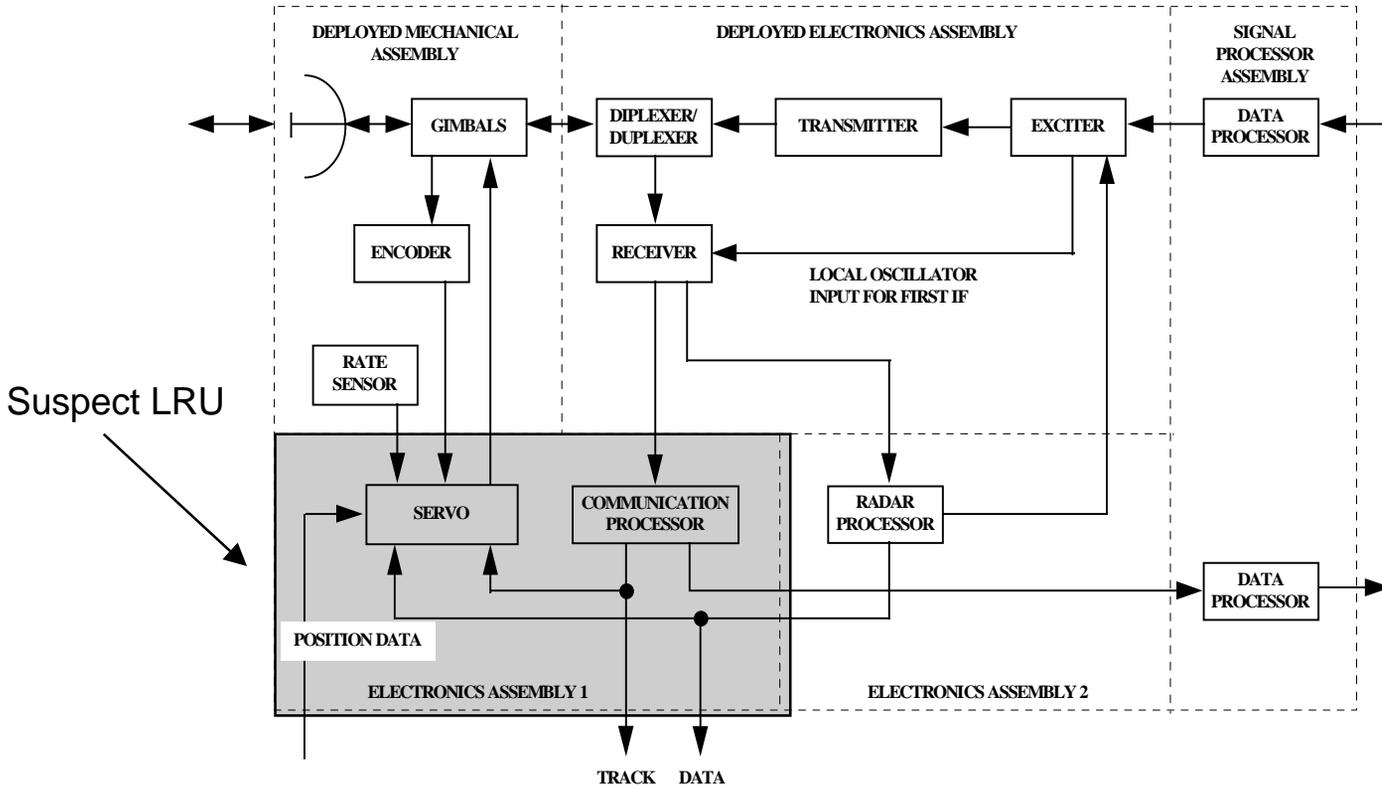
Ku-Band Functional Diagram

- During STS-104 mission, Ku-Band failed to acquire forward link communication

- Review of flight data suggested problem most likely associated with the Electronic Assembly-1 (EA-1) LRU located in avionics bay 3A
 - EA-1 is responsible for processing the forward link communication signal
 - Communication AGC and detect & track flags are generated within the EA-1
 - Detect & track flags were absent during the dropout period
- Comparison of this failure signature to Ku-Band failure history does not show any evidence of a trend or generic problem
 - One previous IFA related to loss of forward link during handover from TDRS West to TDRS East during STS-69
 - Anomaly isolated to failed component on PN/PSK card set

- Based upon the observed failure signature, there is no evidence to suggest a generic problem associated with the EA-1 hardware
- New EA-1 has been installed and all Ku-Band OMRSD testing completed

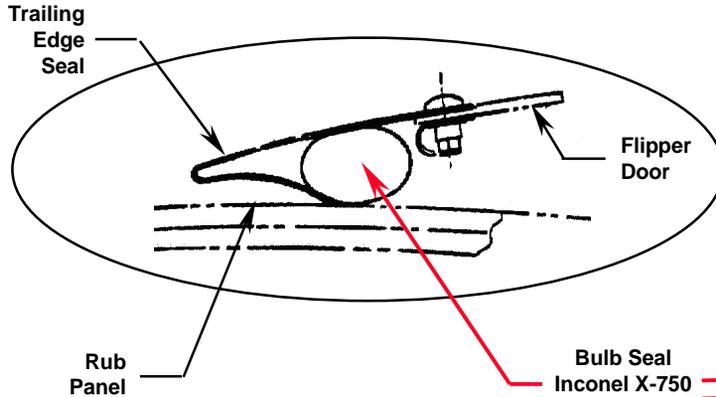
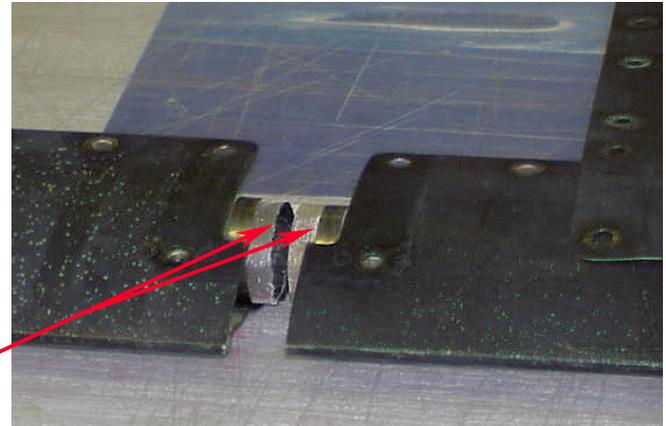
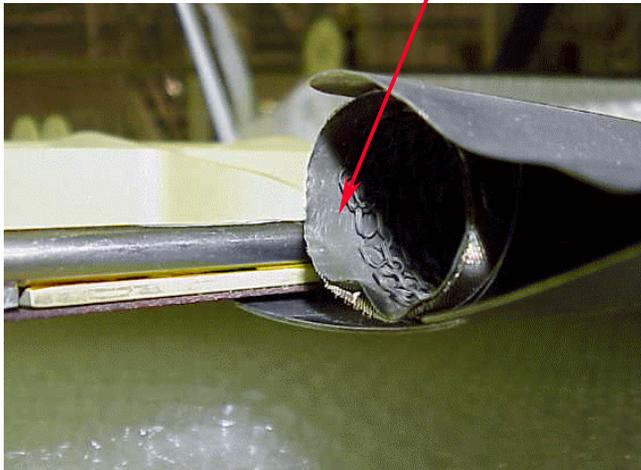
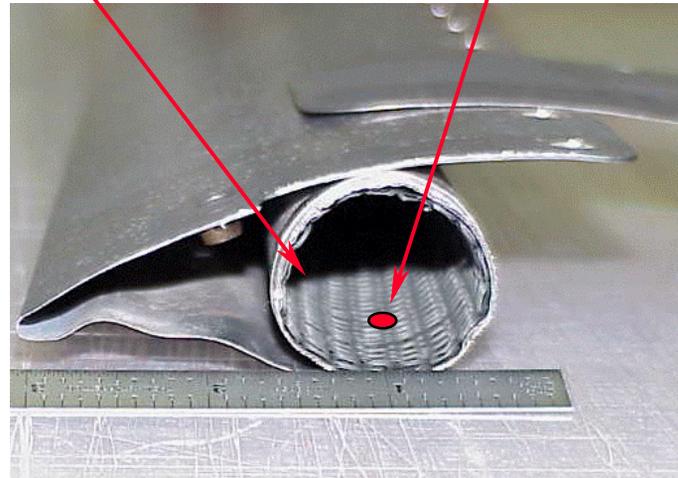
Elevon Flipper Door Trailing Edge Bulb Seal Mod

Bulb Seal
Inconel X-750
Knitted Wire
Spring

Fastener added here at both
ends of bulb seal
